OWEB Project # 207-082
Wiley Creek Fish Passage Improvement Project
Monitoring Report, December 2008

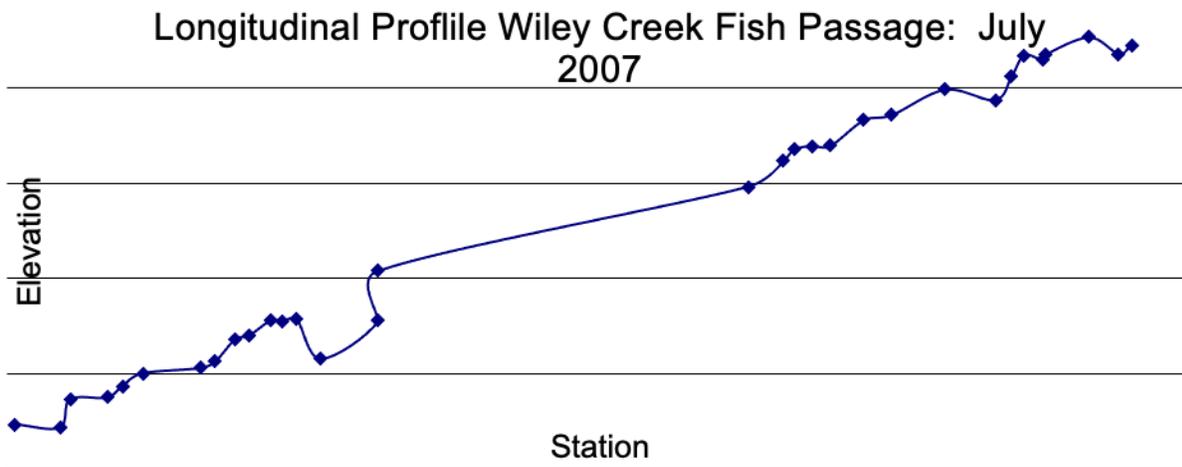
A longitudinal profile was completed in July, 2008 to complement profile taken before the project was implemented in 2007. The graphs for these profiles are embedded below. In the July, 2007 profile the culvert begins at approximately station 50 and ends at approximately 100 and is seen as the straight line with a slope of 8%. The reach slope was 13%. The reach above the culvert was snorkeled before project implementation and no fish were found.

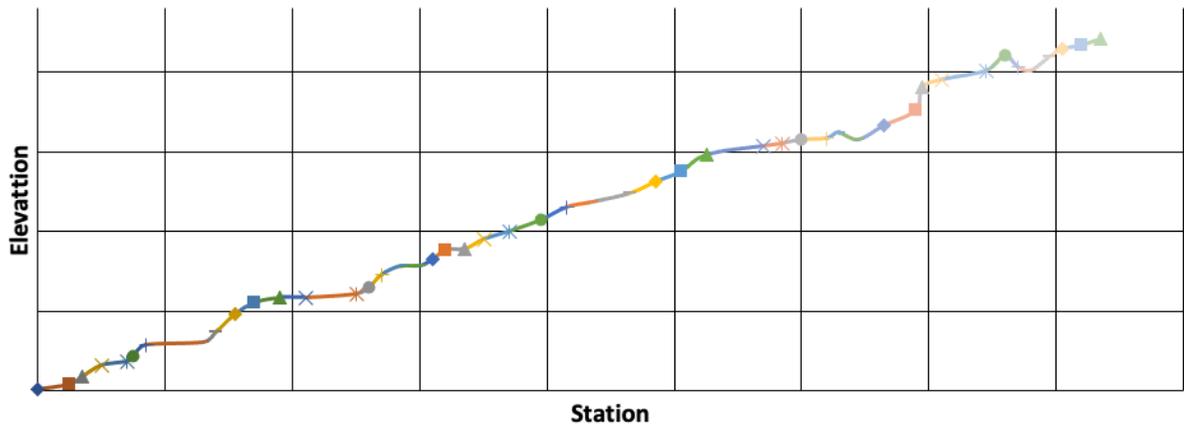
Longitudinal Profile Wiley Creek Tributary Bridge Project: July 2008

The 2008 longitudinal profile is interesting as it clearly shows where the culvert was replaced by a bridge at approximately station 50. While the reach slope remained approximately 13%, it was slightly higher than the 2007 profile as the reach from station 50 to station 100 where the culvert once provided an 8% slope is now among the steepest in the reach at 15%.
